Cal Arts Wayfinding

Narrative Report with Photos and
Commentary

Sharon Toji and Ullrich Hepperlin
November 8, 2016

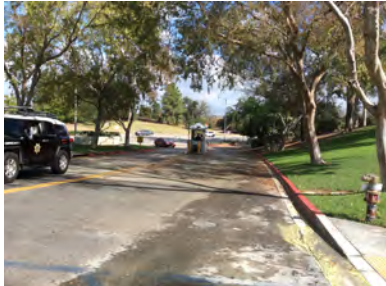
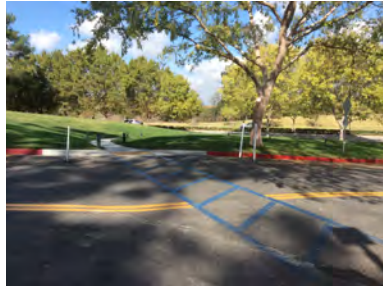
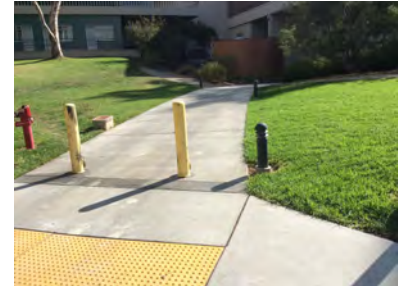
The kiosk at the entrance to the campus does not offer any particular guidance to those who need accessible features. The pedestrian path does have a blue cross-hatched area, but on the other side, it does not lead to the main campus entrance. Without proper directional signage and maps for autos and pedestrians, access is something of a guessing game.

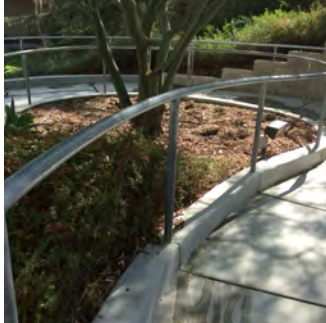
This ramp appears at its entrance to possibly provide access to one of the buildings, but as you look further, it seems to be rather steep. If it is accessible, there should be a sign identifying it.

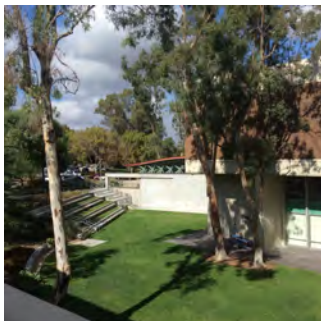
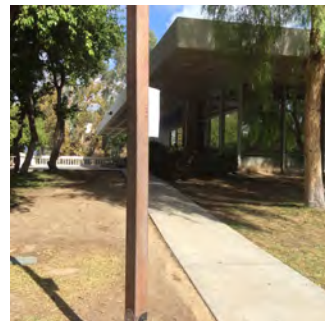
Directly below is a photo of what looks to be an outdoor amphitheater, but there is no visible access.

The accessible walkway to the entrance of the main building, which is actually on the third floor, is not properly marked.

Our initial report does not deal with the exterior wayfinding, but it should be dealt with immediately upon completion of the interior sign program.

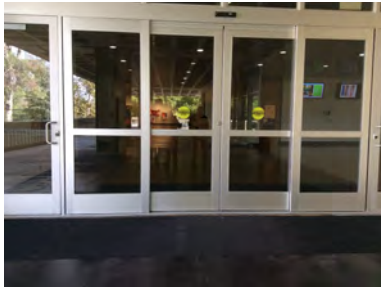
Starting with the main entrance to Floor 3, we notice there are no accessibility signs, although there are the necessary automatic door signs.

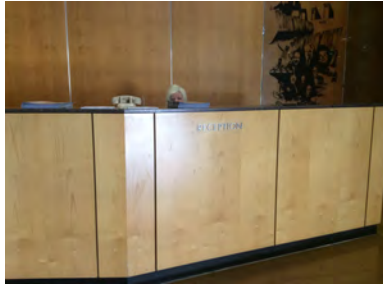
As we enter the main lobby, there is a reception desk but the sign, located on the counter rather than above it, where it would be much more visible, is almost impossible to see. Furthermore, the counter itself is not accessible, and when we asked, we found that there were no maps available.

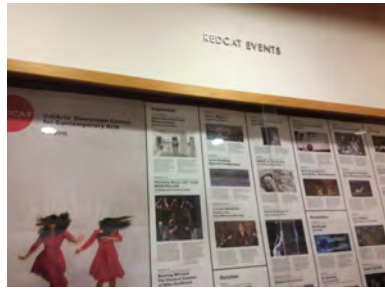
On one wall we can see there are upcoming events publicized, but again, the sign is almost invisible because of low contrast, glare, and the fact that it is too small to meet ADA requirements.

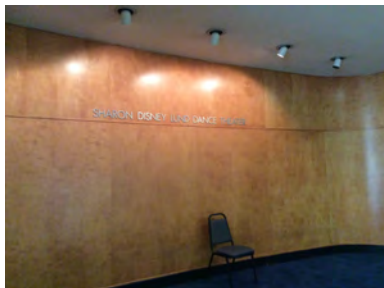
The same goes for the names of the various performance spaces. You can barely see the signs, even though the contrast is a bit better than with the event wall sign. And, there is no corresponding tactile sign at the door to the auditorium itself.

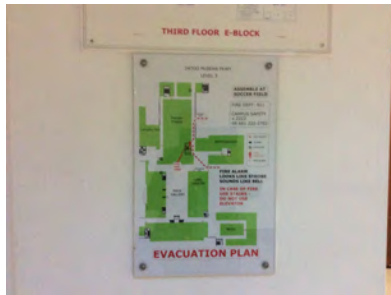
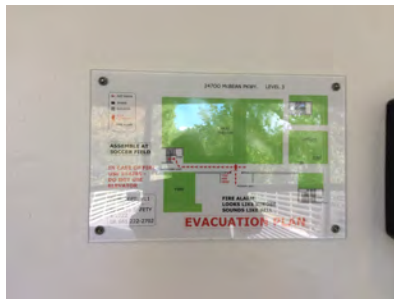
There are numerous problems with the existing signs. Some are actual noncompliance and others are just issues that make signs less accessible although they don't violate any actual standards other than common sense.

Since red and green appear to be about the same shade of grey to about 8 percent of the male population, it would be better to choose other colors for the Evacuation maps. The first photo also has text to identify the location in the building, but it is too small to pass visibility standards. The second sign has a glossy cover, which makes it not compliant.

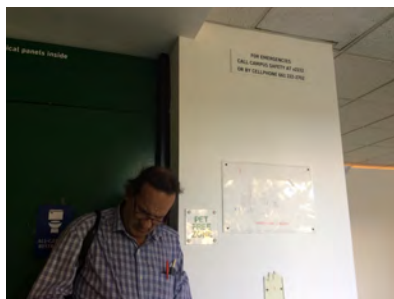
The third sign has some important information about emergencies, way too high for such small text. Although the entrance to the library does have a large, contrasting sign, there is no corresponding tactile sign.

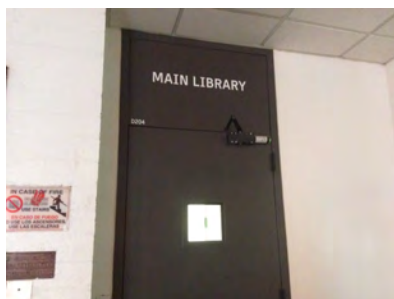
The last photo shows what is the major means of door identification throughout the facility, a tiny visual sign way far above the finish floor, and no accompanying tactile sign.

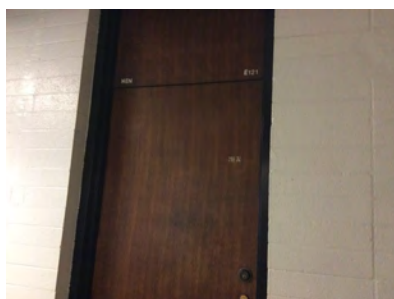
The last issue, which is only illustrated by the absence of signs, is that the different blocks are not identified in most of the building. Our program does remedy that by adding large signs that can be seen from many vantage points, as well as with clear floor plans that show the different blocks on each floor.
