# Dinah's Garden Hotel

## Accessible Identification and Wayfinding Proposal

Sharon Toji

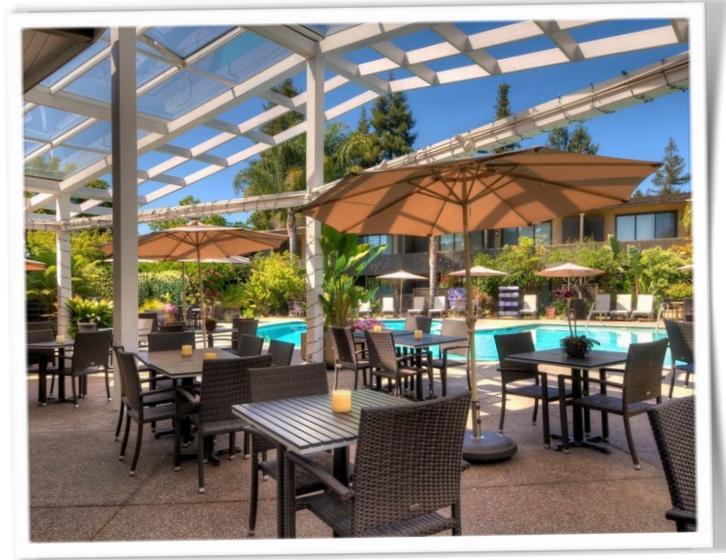
**First Impressions:** Upon driving onto the property, the first impression is how different and charming the layout of the hotel is, compared to the usual motel-like structure one encounters. You immediately look forward to exploring what might be around the corner. However, if you are in a wheelchair or have difficulty with some kinds of pathways, you might also wonder if you will be able to get around as easily as it seems when you first glimpse the lobby building. Experience says that there could be obstacles ahead!

There is accessible parking right next to the lobby building, but the parking signs are not up to date, and need to be brought into legal compliance. Although that doesn't really affect the usability of the spaces, it's good practice to "cross the t's and dot the i's" to avoid potential lawsuits. Be sure that the towaway signs at the entrances to the parking lots are also correct and up to date. That means it's best to use white

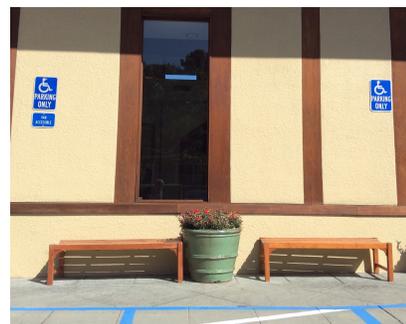
signs with black characters for the towaway signs and fill in the information on how to retrieve a towed car. Otherwise, the general public is apt to ignore the sign if it is blue and white, expecting that it has information for those who are disabled. Obviously, it is a regulatory sign that must be observed by those who do not have a disabled access placard. The State Board that deals with disabled access and keeps track of lawsuits puts incorrect or missing parking signs among the top ten reasons for legal complaints and lawsuits in California dealing with disabled access!

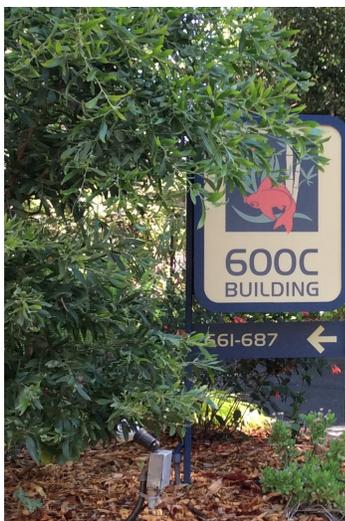
Looking at some other parking spaces around the hotel site, we would recommend placing site maps at several of these locations. The site map near Building 300 is fairly easy to read. It can be enhanced by including a few indicators useful to persons who use wheelchairs. For instance, accessible public restrooms could be labeled with the wheelchair symbol. The elevator locations can be noted. A sign like that would be particularly appropriate near the entrance to Buildings 600 A and B, since that is where the accessible parking is located.

Another problem with the wayfinding signs that are strategically scattered around the site is that there is a regulation stating that no text shall be less than 40 inches above the ground or finish floor. Because of the many trees and shrubs around the area, it would be difficult to place every sign at eye level. However, as many as possible should be raised to a height where they can't be easily obscured, especially by vehicles parked in front of the signs. Certainly specific directional information should be large enough to

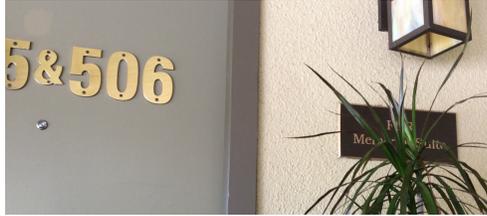
**Design Considerations:** Neither the ADA nor Title 24 are concerned with aesthetic design considerations. However, it is always true that less cluttered environments are easier for people to deal with and that is especially true of people who have sensory based disabilities. The basic aesthetic of the large building identification signs at the hotel is not only visually pleasing, but the signs are also easy to read with reasonable dark on light contrast and non-glare surfaces. A few of the characters in the typeface might be considered a bit decorative in nature, particularly “L,” but the signs are still readable so we don’t think a change is necessary. The danger, however, is that clutter may take over as more and more elements are added to the sign program.

That is especially true of the rooms that have special themes and names. Having a clutter of signs around every room does not enhance the property or reflect the peaceful atmosphere of the water

features and unexpected artworks.

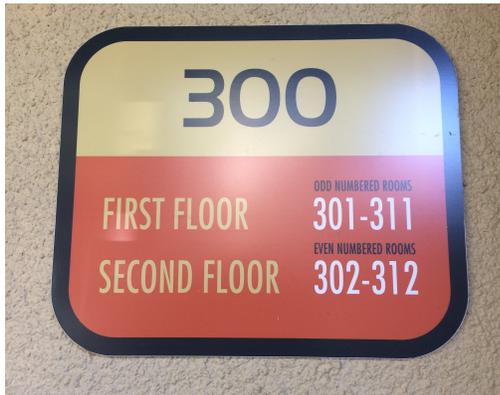
Another issue is that, in what we see as an ill-advised attempt to carry the logo color scheme throughout, the building wall signs have a rather garish scheme that also fails in compliance due to lack of

contrast. In addition, a secondary typestyle is used that is too condensed to be legal, and some of the type is much smaller than 5/8 inch, which is the allowed minimum. These signs need to be completely replaced. Since they deal with room identification, we will plan to present designs for these signs in the first phase.

Although the door number signs are obviously not legally compliant, they can be left in place as long as legal signs are provided adjacent to the doors. However, it does seem as if this is going to add more clutter, and eventually, when it is time to repaint the doors, it might be well to just remove them.

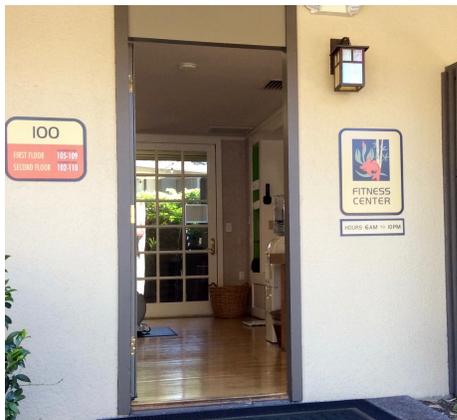
Center should be reviewed, even if they are temporary printed signs, to be sure they follow standards for non-glare surfaces and high dark and light contrast. It appears that there may be two exits, so those doors need tactile exit signs. Since we don't have floor plans with detail, we aren't sure if there is a restroom within the Fitness Center. If so, it will need a sign.

On the exterior, since the Fitness Center is identified, it needs a tactile sign. The "Hours" may need to be larger, and need to be measured to be sure they are 40 inches above the ground. Although the current visual "Fitness Center" sign is attractive and easy to read, adding a tactile sign to the group will look very cluttered, so perhaps the design can be repeated with changes to add the required tactile text.

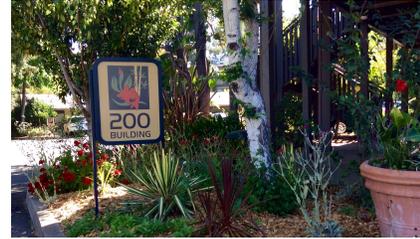
**Building 200:** Building 200 isn't remarkable in any way. There are no "named suites" so the room identification signs can use the most simple design.

**Building 300:** Building 300 is unique only in that it houses the laundry, so that sign needs to

incorporate braille and raised characters, and the hours need to be larger and easier to read with better inter character spacing.

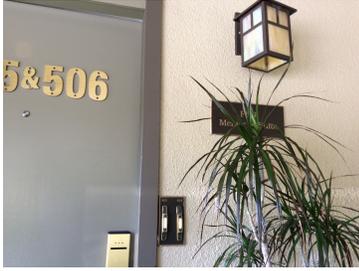
of the FDR Suite at the end of the unit. The FDR Suite (506) is entered through a common foyer with suite 505, so the hallway signs are confusing, and the confusion is compounded by the presence of a plant that obscures the name of the suite. The large brass numbers on the door were meant, I believe, to express the importance that the family gave to the suite, named to honor FDR even though he never stayed there. However, at this point, the effect is just overwhelming, rather than impressive. As a person who shares in the admiration of FDR, I will make sure we do our best to propose some changes for this unit signage that might make it less confusing, and at the same time make the name of the suite more visible.

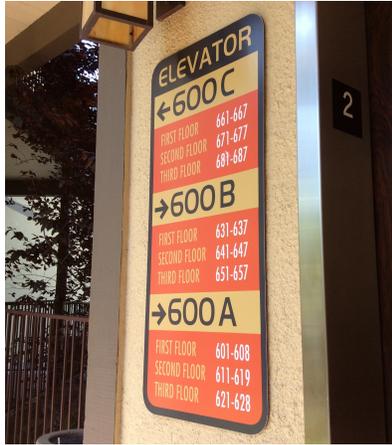
There are a number of large floor and room directories at the two elevators that need to be redesigned. They are so crowded with information, that I doubt that most people really look closely at them. The unorthodox numbering is what triggers the necessity of so many extra signs in this area. With a more logical system, where each floor would have a sequence starting with the floor number, not only would emergencies be handled more quickly, but many fewer signs would be required.

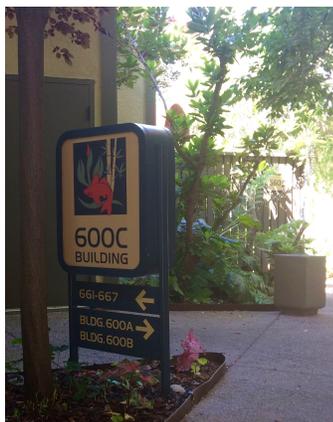
If we take a closer look at this building sign, we can see that the room numbers for the first floor of 600C are included on the sign, but are too low and too small to really have much effect. Unfortunately, these signs were designed and placed without observing the ADA and Title 24 regulations for wayfinding signs.

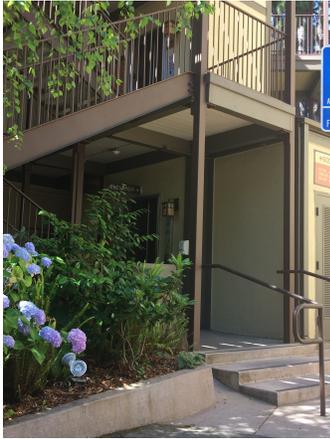
The major entrance to the 600 building complex between 600A and 600B appears to be inaccessible to anyone with a mobility problem, due to the steps that approach the elevator. Without directional signs, you have no clue that if you wind around behind the structure you can get to the elevator and save many steps if you need to go upstairs in 600A or 600B.

Ironically, although this is the least accessible entrance to the complex, the accessible parking is placed here, and I understand that this is where tour busses unload, which might bring individuals who need access.

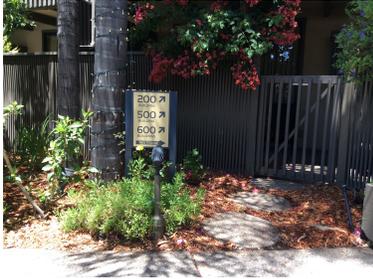
These small post and panel signs are very readable, but they are also mounted very low. That is one problem to solve, and the other is to determine accessible pathways. These signs give us no clue as to whether or not someone with a mobility problem could navigate the path. And the restroom sign, very important, is way too small to read from a distance.

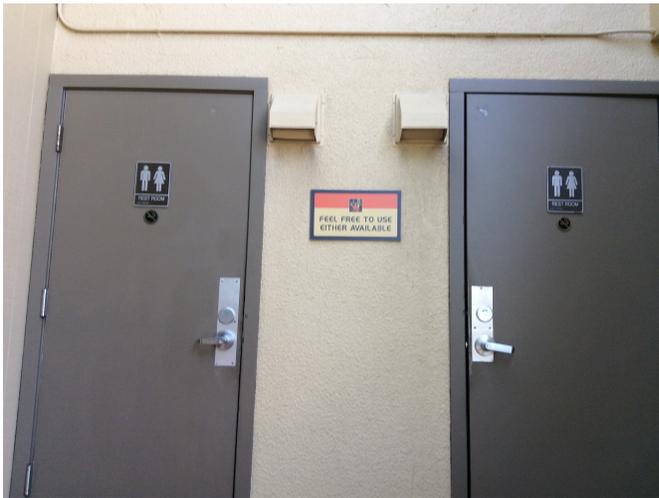
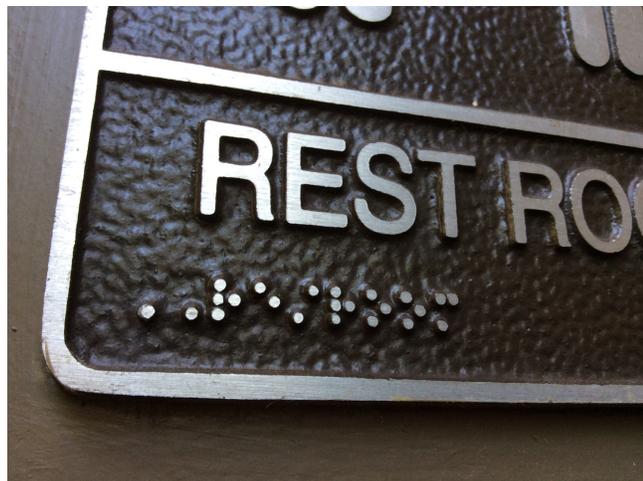
use. Unfortunately, the signs identifying them are completely inadequate. Metal signs are virtually impossible to make truly accessible, because of the process that is used to make them. These have incredibly sharp edged characters, and the braille is flat on top, which makes it

sharp and unreadable as well as illegal. The posted sign attempts to be welcoming to all, in the spirit of acceptance, but would be unnecessary, and the situation would be just as welcoming, with correct tactile signs identifying a non-gender specific

pictogram, along with the required high contrast geometrics that every California restroom must have. Even though these signs are supposed to be readable by touch, even if they did not have such uncomfortable edges, and even if the braille were not illegal, they would be much too high off the ground for many people to read. The close-up photograph of the tactile elements shows just how important it is, when choosing a manufacturer of tactile signs, to pay attention to detail. Check out samples of the signs to see if you could read the raised characters.

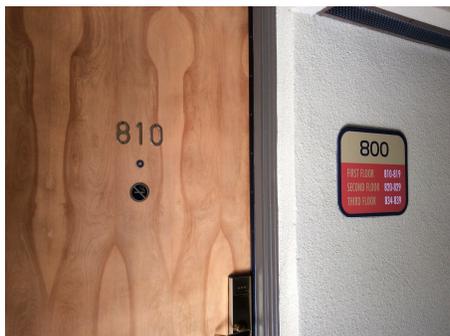
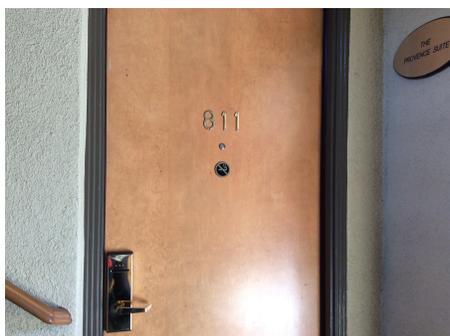
The current sign system in Building 800 is, for the most part, similar to what we find in the smaller buildings. The door numbers are a little smaller, and there are some difficult situations where the stairways are very close to the doors and create an obstacle to mounting the signs properly. If the doors open inward and have closers, the federal exception could be used, and the tactile sign could be mounted directly on the door. Suite 811 is a good example of this problem, which must repeat on other floors as well.

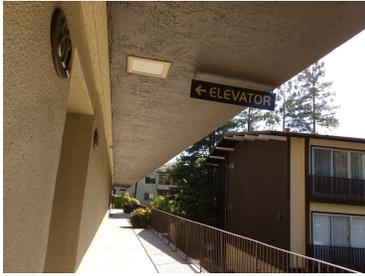
There is an elevator down a short corridor entered from the outdoor walkway, and an overhead sign clearly directs to it. There are also room signs on each side of the hallway entrances. Those signs could remain for the time being.

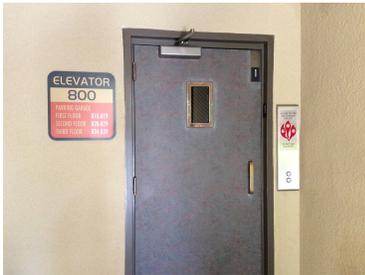
The elevator itself is ancient, and the door is so heavy that it is not accessible to anyone without quite a bit of upper body strength. The hoist ways are too small to have normal signs, which are really meant to be accessed from inside the elevator. Instead, there is a huge shiny brass sign on the inside of the door at each level. We suggest removing that sign and replacing it with something easier to read, both visually and by touch, so someone with a vision impairment could be sure that they had reached the correct floor.

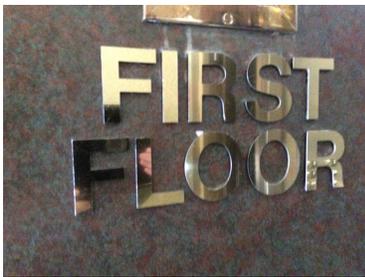
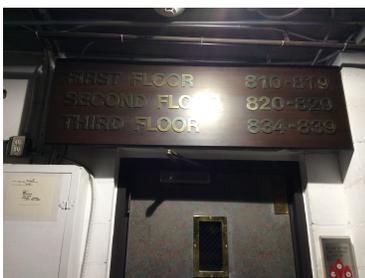
Below, in the basement, the elevator might be usable by someone in a wheelchair who arrived by car, although they would likely need assistance to open the elevator door. The elevator in the basement has a huge floor directory, which is outdated and very hard to read, so it should be replaced.

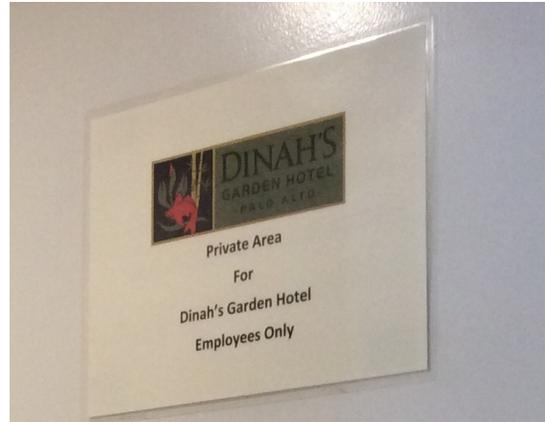
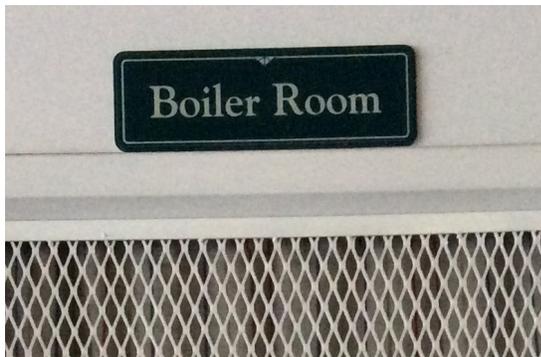
The basement is the location of employee areas such as a locker room and break room. They are not identified, but do have signs indicating they are employee only areas. Those signs only need to be checked for

minimum type sizes relative to mounting height and a matt finish, since they are very readable in terms of contrast. However, if there are toilet facilities, it might be necessary to provide tactile signs for those. They can still be labeled for staff only use.

The only room that currently has a room sign is the boiler room. Therefore, a tactile sign must be provided for it. In any case, the local Fire Department probably requires that the boiler room be identified.
