# Marina City Club

## A Plan to Communicate Access

# Accessible Communications

## An Action Plan

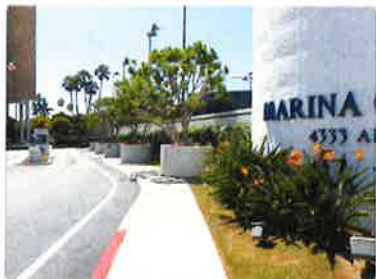
A visitor coming onto the site using a wheelchair or scooter is at a huge disadvantage. There is no safe accessible path of travel from Admiralty Drive to the entry kiosk, or from there to any of the facilities or residences, or to the leasing office. Although a sign company can certainly provide a sign with a phone number for a person to call on their cell phone, so that an escort can meet them and get them safely to a point of entry or elevator, a shuttle making regular rounds would take care of the problem more efficiently. Even if you are being dropped off by an Access van, you may not know exactly how to get to the most convenient location to access your destination.

Third, and even more expensive, but of great assistance not only to those with walkers, scooters and wheelchairs, and even their caregivers, but to parents with children in strollers, would be to completely refinish and level the walking paths and sidewalks. Widening the sidewalks, providing curb cuts at crossings for wheelchairs, along with detectable warning surfaces for the blind and visually impaired would provide a much safer path of travel for everyone, since almost all access to the facilities is along vehicular ways or through garages, where the cars often seem to zoom around the curves.

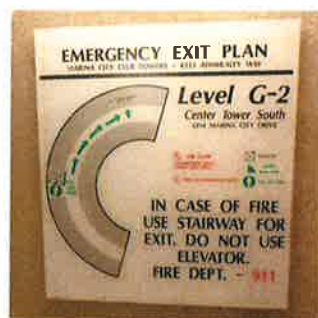
Currently, most of the elevator lobbies in the towers have evacuation plans posted, but many of them are out of date, some show no path of travel at all, and some would take people in the wrong direction during an emergency. The map shown is a good example of that. The exit is just a few feet to the right, but the path would take you instead to the tennis courts, which are not even on the grade level. Bringing the maps up to date is crucial, and correctly designed signs can also be very helpful for general wayfinding within the towers.

Once again, it is vital to make sure that every map is oriented to its viewers, so the installation location must be determined, and each

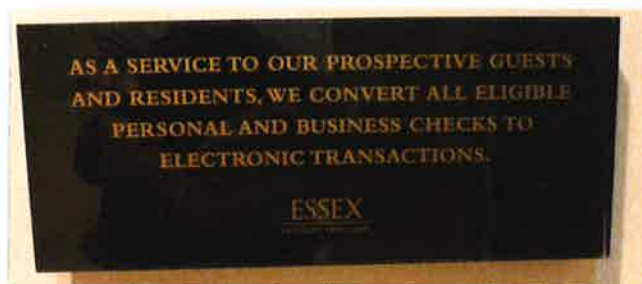
The sign that directs the visitor to visitor parking, and also to the lobby is mounted on a column at the entrance of the resident parking garage that is beneath the tower. It would be very difficult for most people to read from a vehicle, and is located so that it would be almost impossible for someone in a wheelchair or using a walker to get to a safe location to read it. As with most of the signs, italics are used, which are not allowed for accessible signs, all characters are uppercase, and the surface of the sign is very shiny. All of these make it difficult for people with any vision impairment to read.

To add to the confusion, there are arrows in three different directions, ahead and to the left for visitor parking, straight ahead for the lobby, and directly to the left for an unnamed accessible feature.

However, assuming you do find your bearings and head to the left toward the lobby entrance, you won't find any curb cuts, and will have to navigate a curb. The door itself is probably too heavy for ADA/Title 24 standards, but there is no wheelchair symbol, so it's not misrepresented. However, it also indicates that there isn't any legal accessible access to

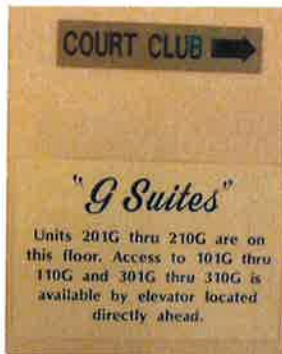
The other door at this end of the corridor leads to the apartments that we suggest calling, as they are in the garage, the "Studio Suites," and designating with "S" rather than "G." We think using the "G" confuses the issue, since "G" stands for Garage in this complex, although it usually stands for "Ground Floor." That will distinguish the elevator within this area as being separate from the elevators located in the garage, since there is no connection at all between the two.

If you are in a wheelchair, you would be forgiven for thinking that, if you are visiting a friend in these apartments, you could go through this door and access their unit. Although the sign on the door tells you that you can access the apartments, and will also find an elevator within

so that you can get to the first and third levels of the apartments, that is not so. When you do open the door, you are confronted by a stairway.

Obviously, the sign needs to state clearly that there is no wheelchair access to any of the Studio Suites on any of the three levels through this door. You will have to return to the lobby area behind you, go to the elevator, actually leave the building and go through the garage to get to a doorway that will take you into the Studio Suites on one level, and the elevator within that set of units that will take you to the other two levels.

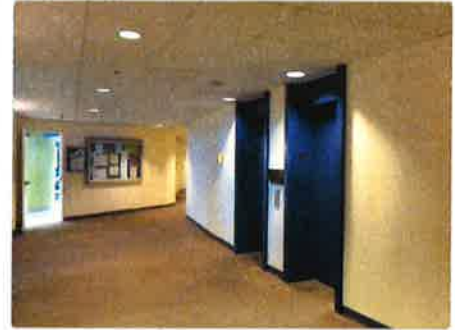
If we return to the area on the second floor of the Center Tower that is the center of activity for people who are not residents, as well as for active residents, and look at the area around the elevators, we find that there is poor visibility from that area to the surrounding corridors, and virtually no directional or informational signs.

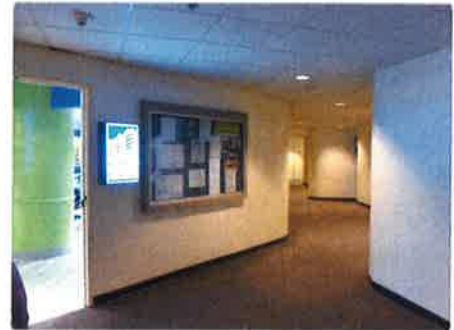
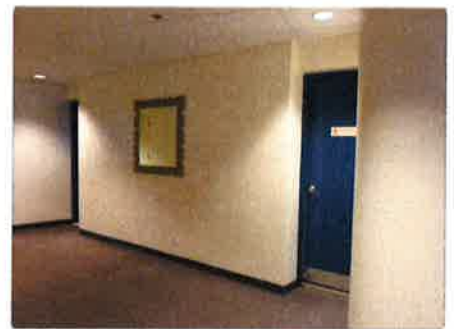
To the left, about all we can see is the entrance to the City Cafe, which has a logo sign. However, if we were to venture down that hallway, we would find public restrooms, a large beauty salon, and around the corner, the entrance to the swimming pool, along with more restrooms. The salon does have a logo sign that becomes visible as you proceed along the corridor, but no one would guess that there is another corridor to the left of that leading to the pool area. We suggest that a directional sign to these amenities be posted to the left of the elevators.

As you approach the salon, an additional sign will have to be posted directing to the swimming pool area, and accompanying restrooms. It's important to design the integrated system for the entire facility prior to doing this, and not order piecemeal signs that may or may not comply with the most recent accessibility standards. The hodgepodge of signs

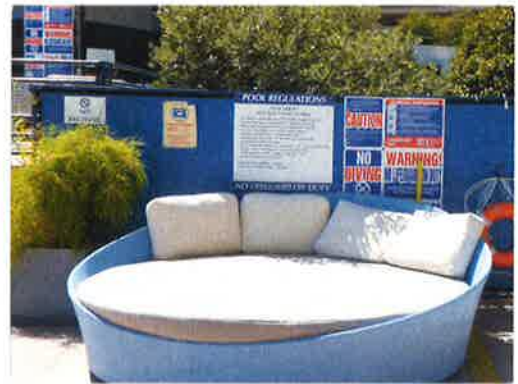
Just as with all the other signs, there is no particular design standard, and there are a number of non-compliant elements. New 2010 standards, for instance, require that signs not be mounted lower than 40 inches above the ground or floor, so they can be easily read. Any information about the facility and its use, or directional signs must have minimum 5/8 inch high characters, and they must follow the general rules for visual characters.

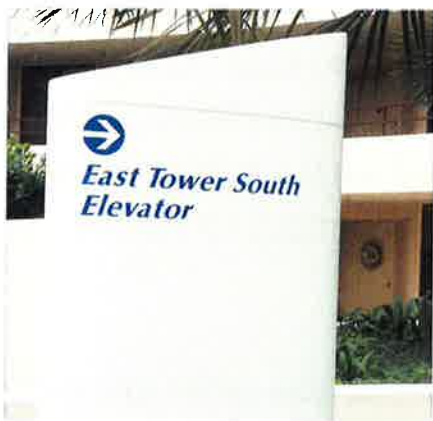
normal vision and get close enough, are easy to read since they are an attractive dark blue on a white background.

Unfortunately, even though it is legally acceptable to have directional signs with tiny, 5/8 inch high characters, these are in italics, which is not compliant. On top of that, the arrows are sometimes misplaced or strangely placed, so that they don't always seem very helpful.

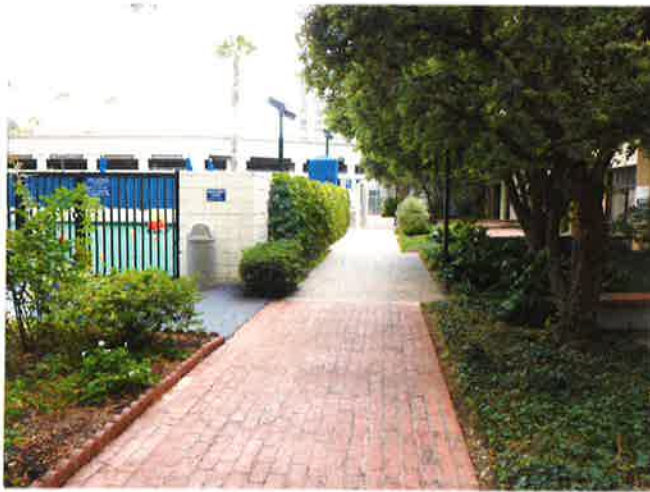
Most of the residents who are ambulatory do eventually learn how to access the specialized areas of the site, such as the various swimming pools, tennis courts, and “Doggie Lands.” However, that’s either a trial and error task, or requires finding someone who knows how to wend their way through and around the massive garages to the areas behind and above. For instance, around the East Tower entry area, and behind the Doggy Land located there, there are numerous signs pointing to the “Monterey Room.” These signs are so plentiful, the uninitiated might

expect some kind of major destination, ready for a major meeting or luncheon, or perhaps some kind of crafts room. On the other hand, the signs are installed so low, that most people probably walk right by them. They certainly don’t meet the 40 inch ADA standard.

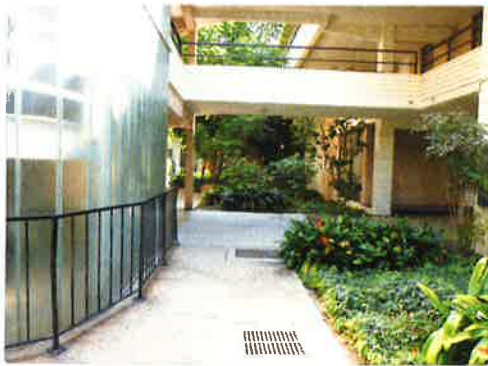
Each area of the apartments is served by a central circular tower that holds a staircase. Right at the same area is a unit with an elevator leading to a bridge that accesses floors two and three of the apartments, as well as the laundry facility for that set of apartments. The apartments themselves, especially on the ground floor, might be accessible, but the

walkways are quite uneven, with a lot of different materials making up each section of the walkways. Putting in new walkways would greatly improve the accessibility to the entire Promenade area.

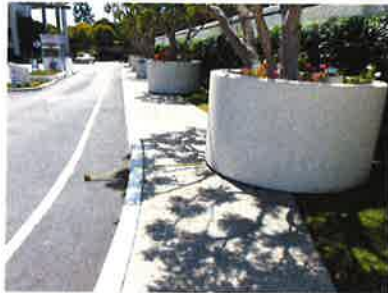
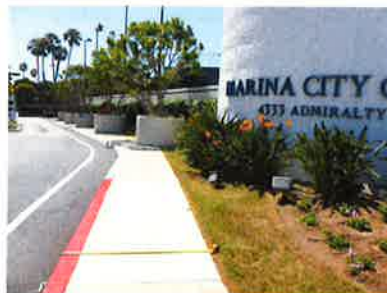
There is no walkway wide enough for one wheelchair, let alone two, entering the site.

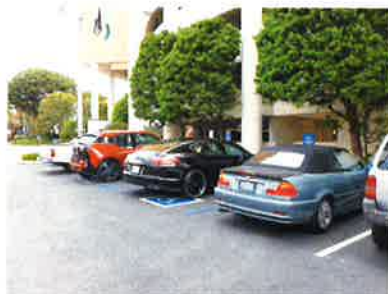
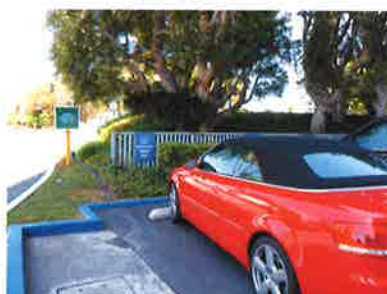
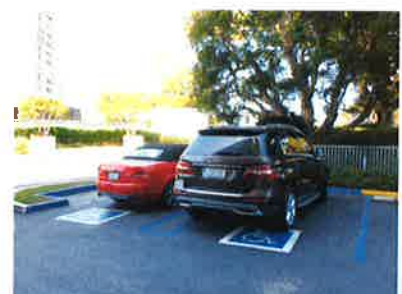
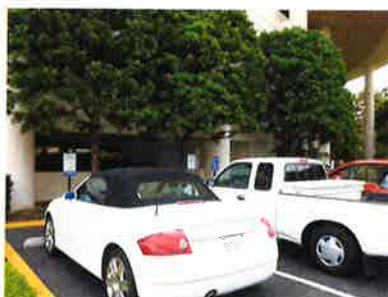
The accessible parking signs are outdated, and use the objectionable term “handicapped.” There are no towaway signs installed at any of the entrances, and parking does not seem to be enforced.

The lack of compliant parking signs is a major cause of official legal action in California.

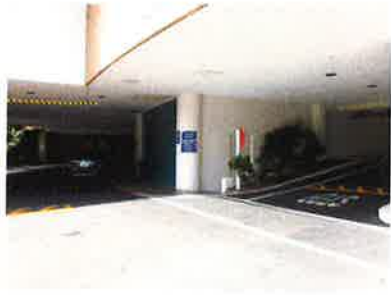
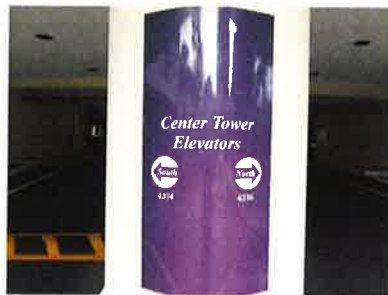
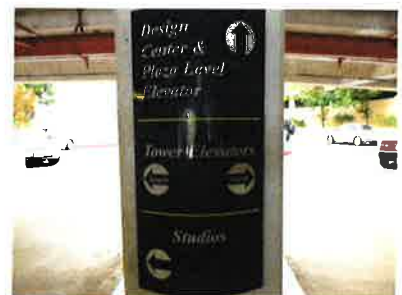
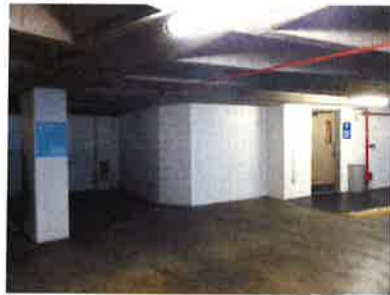
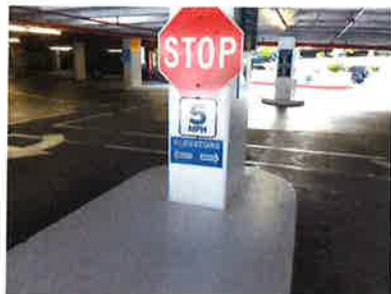
Although all the signs shown can be seen from cars, only pedestrians can read them. The sign directing to the main lobby is far too small for most people to see until they are right there. The signs directing to the elevators in the garages are difficult to read, and can be confusing. For instance, you would never know that the numbers beneath the arrows on the purple sign are the street addresses of the buildings. The black sign is difficult to read and some signs are too close to the floor. There is no directional sign for the elevator in the garage. During the three days we were on site for extensive periods, we had several

tenants stop and tell us that they had a hard time locating the elevators because of the lack of prominent signs. A constant refrain from residents who asked what we were doing was, "please do something about signs so we know where things are. I still get lost."

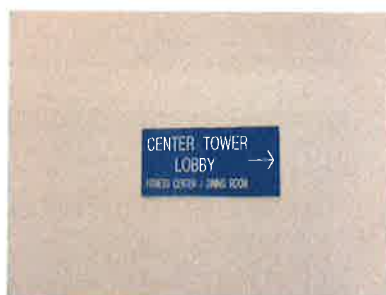
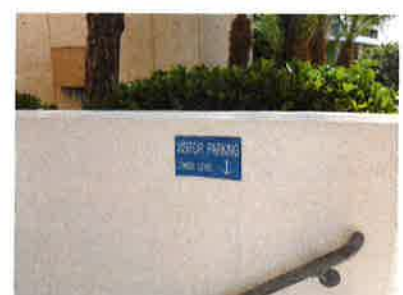
Non-residents, especially those who are new members, get little assistance from signs. Locating the Court Club, the tennis courts, or even the guest parking is difficult, because signs tend to be haphazardly placed or difficult to read.

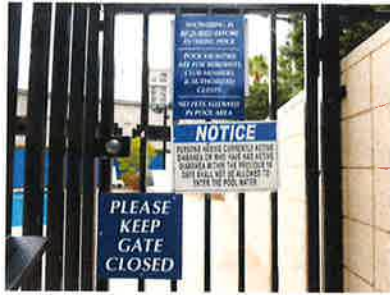
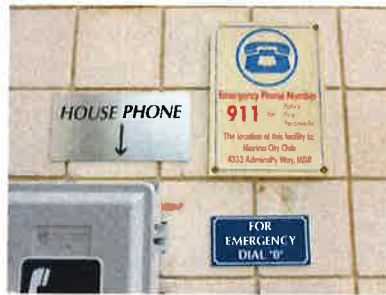
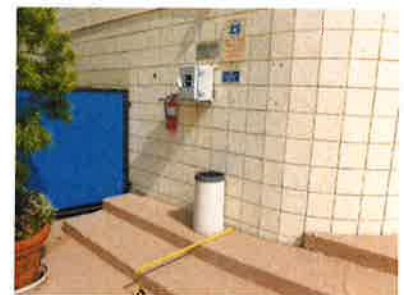
Both residents and members using the pools are confronted with a huge amount of sign clutter. In the center sign above, note that one sign says that the emergency number is 911, whereas the sign below directs people to “Dial 0” in an emergency. The photo on the right demonstrates the difficulty that a short person or someone using a wheelchair would have in reading the signs or using the emergency phone.

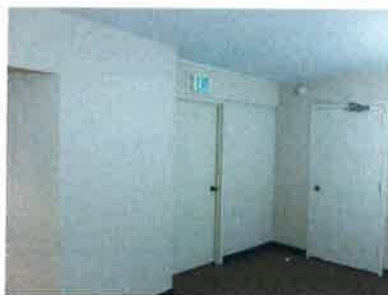
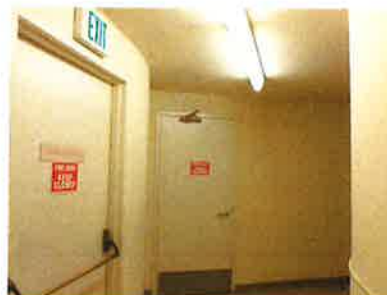
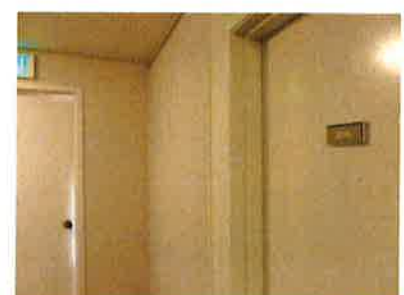
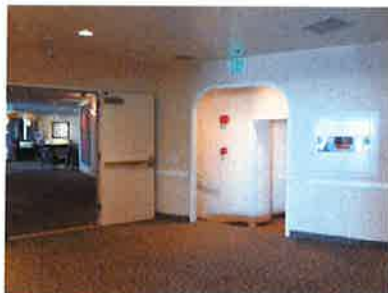
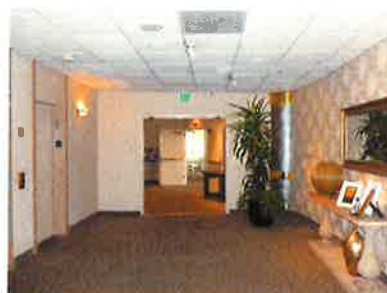
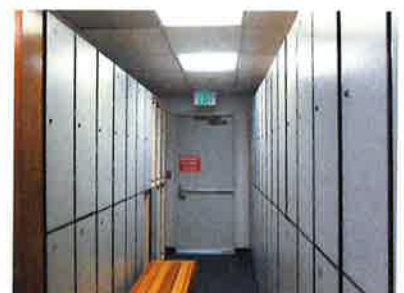
Tactile exit and exit stair signs are completely lacking throughout the entire facility. This is a major life safety issue.

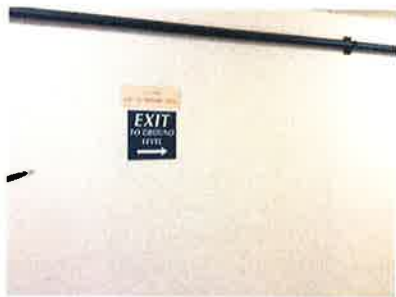
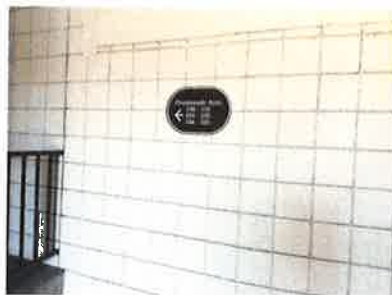
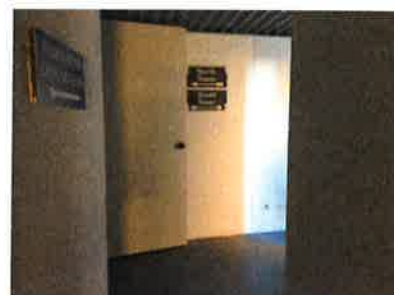
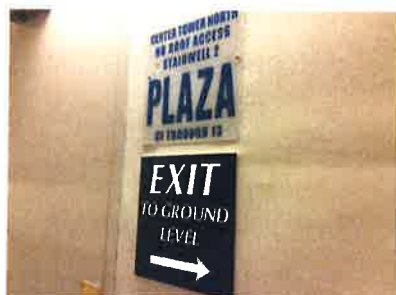
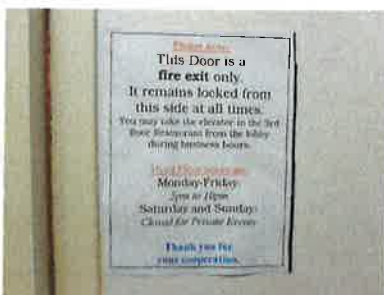
This is a collection of stairway directional signs. To the left is a sign posted in the stairwell leading from the Restaurant.

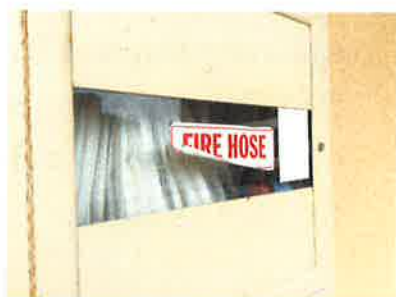
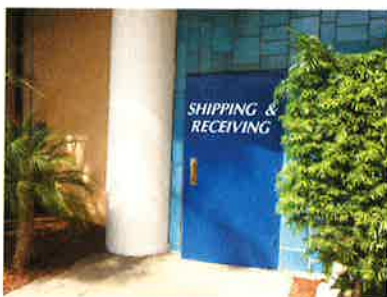
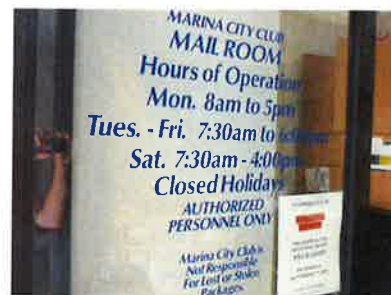
There are a varied group of small sign problems that need fixing, such as the Fire Hose sign that needs replacing. The required "Shipping & Receiving" tactile sign at the side of the door would be difficult to locate, but a small one could be placed on the pillar to the left. The Mail Room sign needs to be redone without the italics.

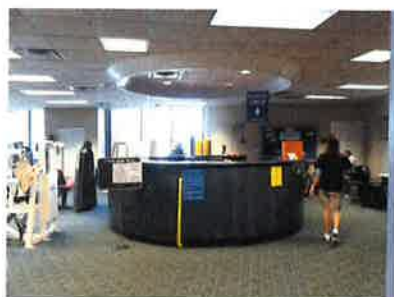
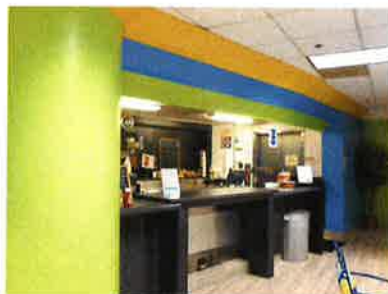
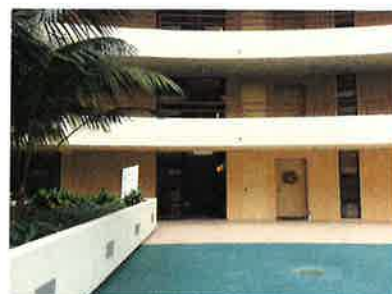
The Fitness Center, the City Cafe, and the Restaurant and Bar upstairs are all venues that need to have unified, compliant and uncluttered sign systems installed. The Tower residence floors also need better directional signs, especially to direct to elevators and central services.

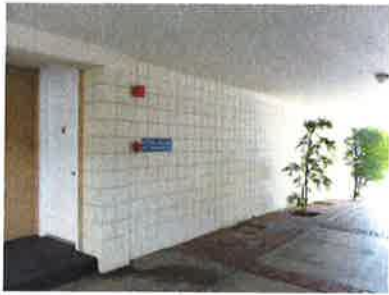
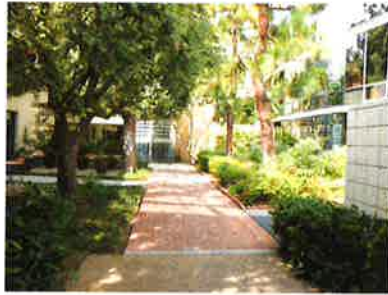
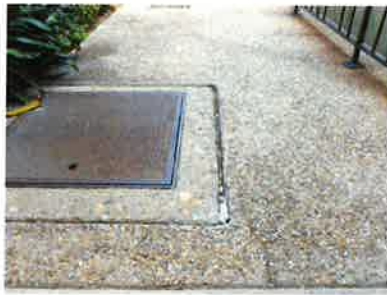
We've mentioned the many problems of the Promenade area. Chief among them is the virtual impossibility of getting there by wheelchair. Even for other elderly walkers, the walkway are dangerously uneven. The address signs aren't clear or self-explanatory, and there are commercial destinations that need to be accessible.

This seems like such an attractive area, that a facelift for the signs could do a lot of good, and also help bring the area into more ADA compliance.

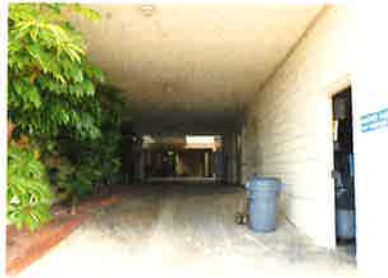
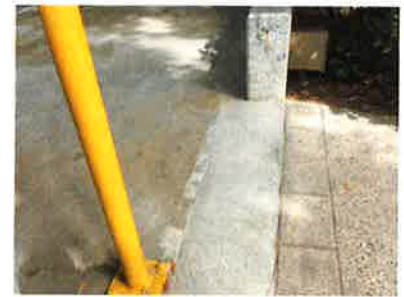
Although the first photo is not an accessible curb cut, but a driveway meant for boats, it does show that some accessibility might be achieved. There is also a makeshift curb cut leading to the Central Tower elevator.
